P/N 90151 / ed. 2006 - 01 / Landskrona

Innovative Vehicle Technology

The Haldex concept

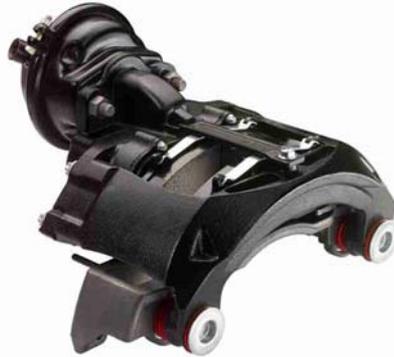
- Modular design
- Two piece calliper
- Quadruple slide pins
- Unhanded
- Low hysteresis actuator
- Twin tappets / spindles
- Heat protected tappet bellows
- Clearance sensing adjuster
- Repairable
- Spare parts kits available

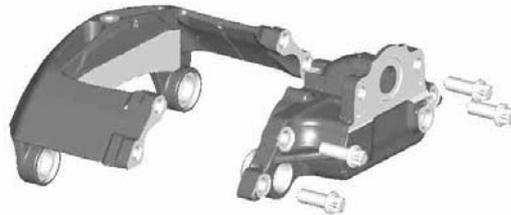
Two piece caliper

- Completely unhanded
- Light weight and small package size
- Accommodates different rotor thickness by changing one piece
- No sealing elements subject to high loads

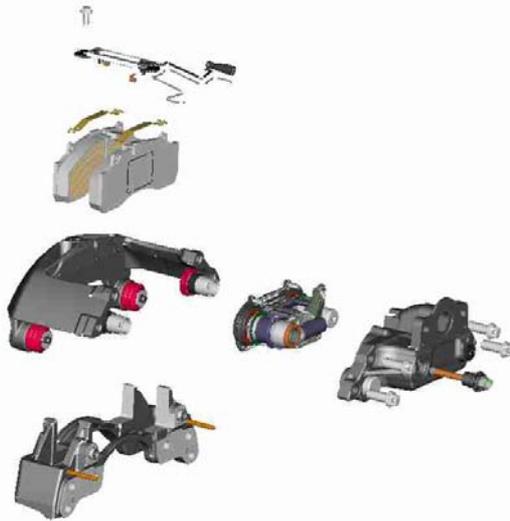
Common application module

- Twin Tappets
- One self contained application unit for multiple brake sizes
- High efficiency with cylindrical roller bearings
- Serviced as an assembly
- Silicone rubber bellows
- Heat protecting springs (Optional)

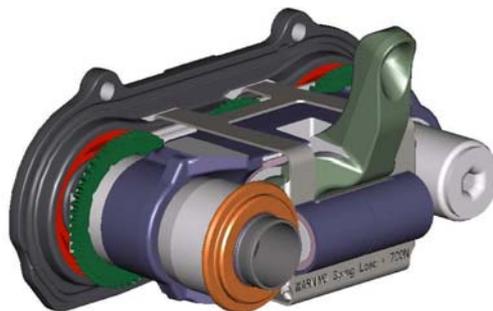
Mechanism / Housing

The same Mechanism in
DB19, DB22 and DB22LD
Mechanism Housing

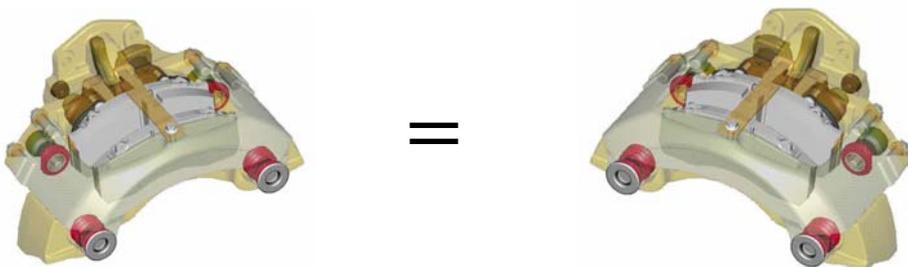
Tappet protection

- Protection Springs - protection against heat radiation and physical damages (peak à 300°)
- Rubber bellows – protection against water and dirt ingress.

(Operation Temperature -60° to $+250^{\circ}$, peak à 300°)

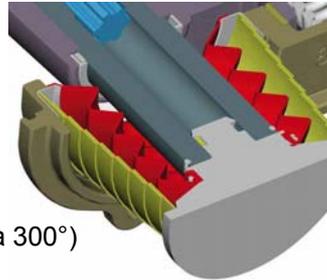
An important function : The sliding function

- Stainless steel slide pins for improved stability and corrosion resistance
- Self lubricating, Teflon® slide bearings for low friction
- Dust protected with silicon rubber bellows
- Protective solid cover in calliper
- One kit fits 3 brake sizes

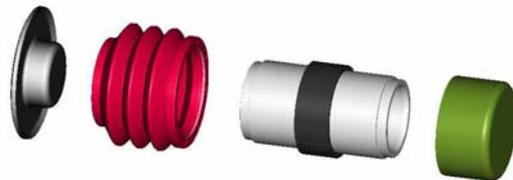
Corrosion test

14 days (Haldex)

3 days (competitor)

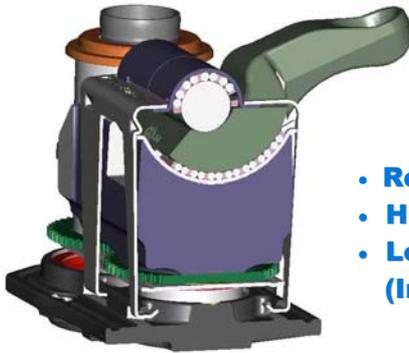
2 x 2 needle bearings = low hysteresis

- **Reduced friction**
- **High efficiency**
- **Low Hysteresis**
(Important for proper ABS-function)

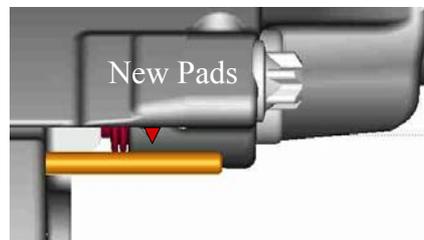
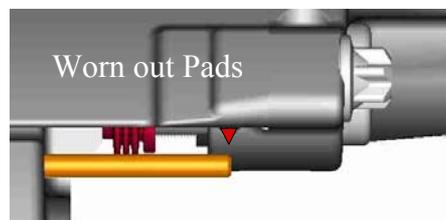
VWI, Visual Wear Indicator

- **Casted arrow on the caliper**
- **Slotted steel pin seated in the carrier**
- **The distance from the arrow to the end of the slotted pin indicates remaining friction material**

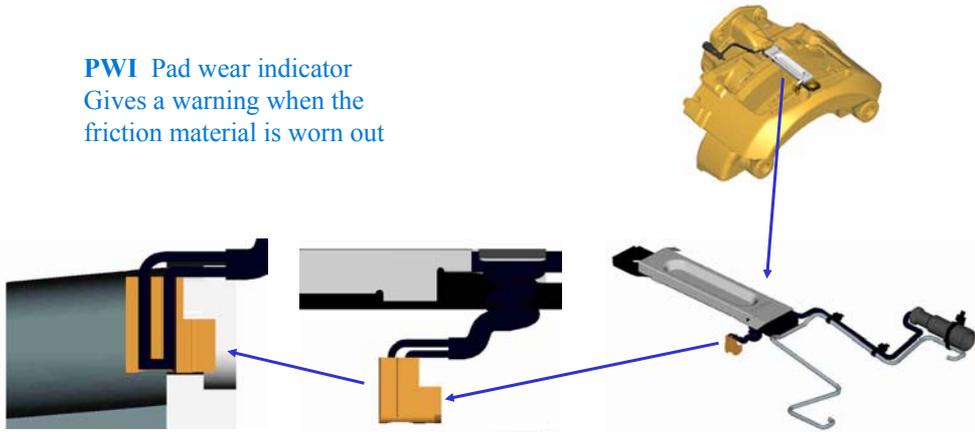
Wear indication system, PWI

PWI Pad wear indicator
Gives a warning when the friction material is worn out

Type of wiring and connector according to customer demand

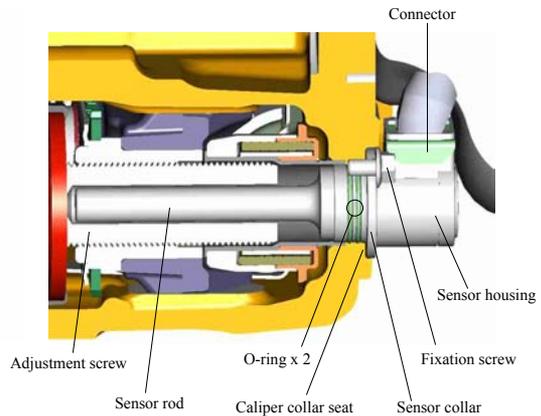
Wear indication system, PWS

PWS Pad wear sensor
CWS Continuous wear sensor

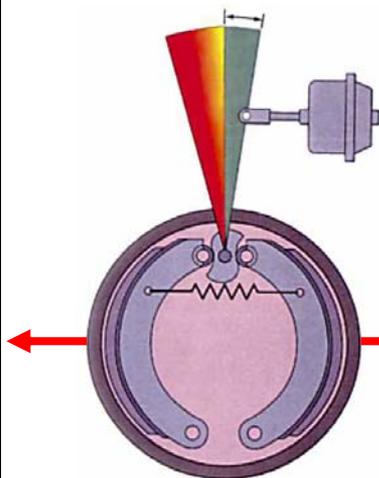
Limits of the drum brake

Decreasing efficiency at ~300°
Extended brake chamber stroke.

Increased temperature =
increased elasticity
of the wheel brake
components.

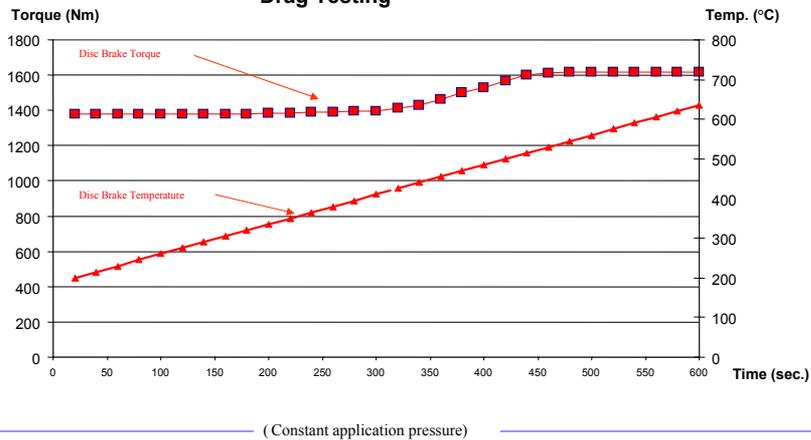
Disc Brake Characteristic

Drag Testing

(Constant application pressure)

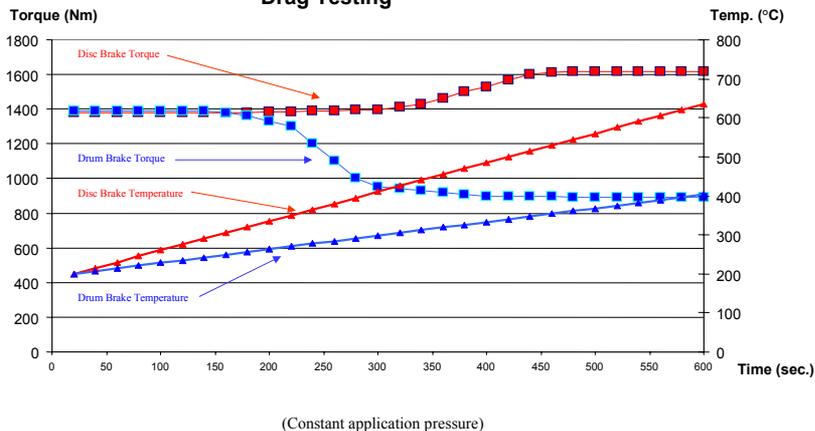
Characteristic: Drum Brake compared to Disc Brake

Drag Testing

(Constant application pressure)

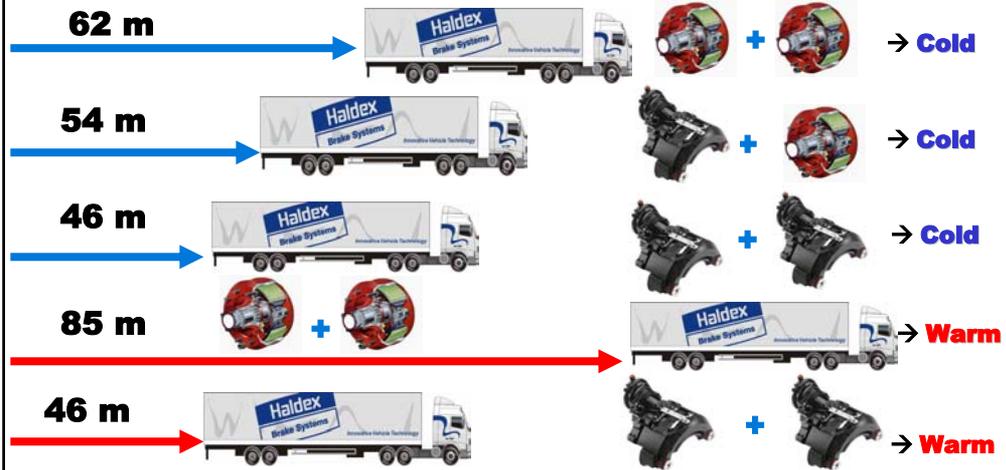
Safety → Brake Distance

Tractor + semi-trailer, 40 tonnes, speed 85 Km/h

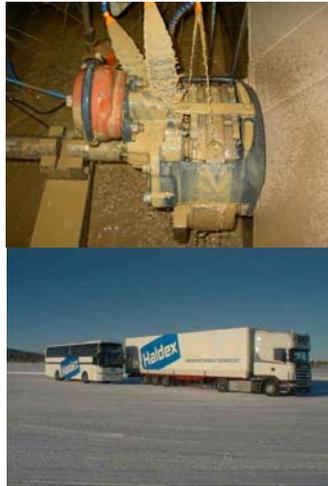
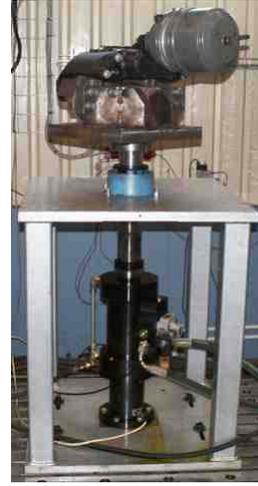
- Dynamometer test
- Torque test (Chucker)
- Dirt Chamber
- Fatigue (Puls test)
- Vibration test (Hydropuls)
- Vehicles (Lab)
- Vehicle field test

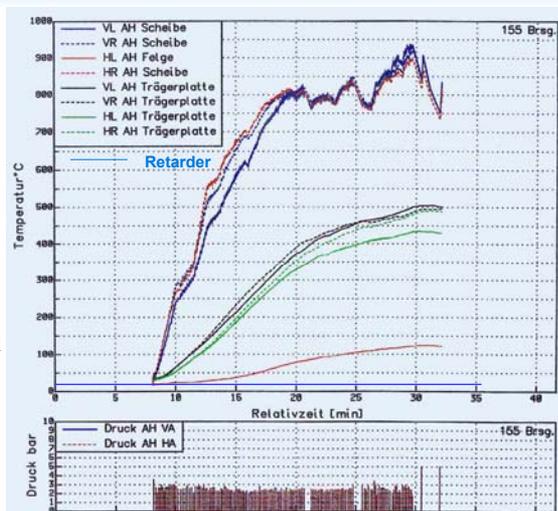
Rossfeld Test

- Two-axle drawbar trailer
- Single wheels
- Total weight: 18 tonnes
- Descent time: 23 minutes
- Brakes applied ~150 times
- Speed increased to 35Km/h thereafter, by braking, reduced to 25Km/h, increased to 35Km/h again etc.

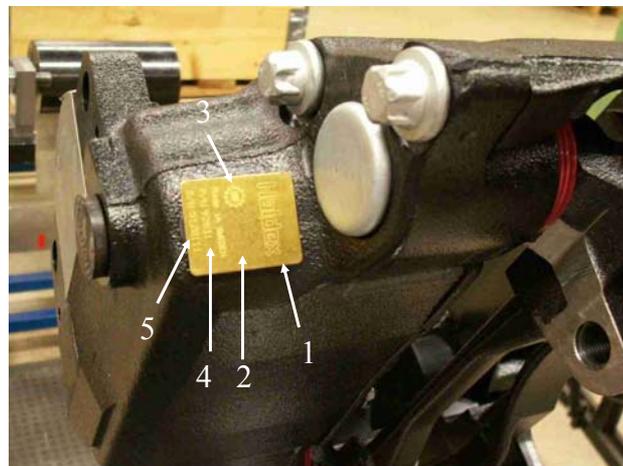
Product Identification

1. Haldex/OEM logo
2. OEM P/N (if required)
3. Haldex EC (origin)
4. Haldex P/N
5. Haldex S/N 5120111
5 = year, 2005
12 = week No. of the year
0111 = sequential No.

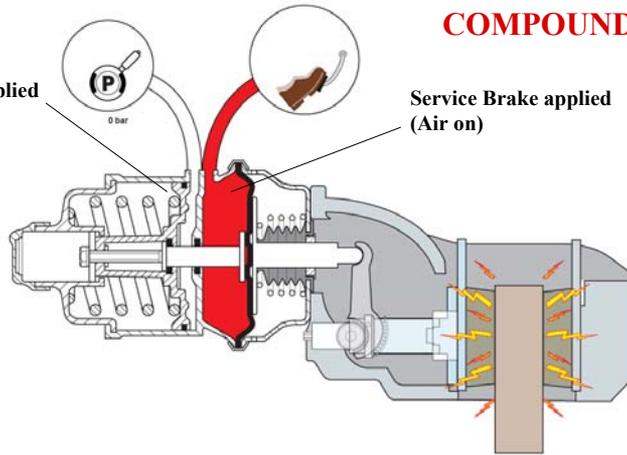
Spring Brake Chamber

COMPOUNDING !

Parking Brake applied
(Air off)

Service Brake applied
(Air on)

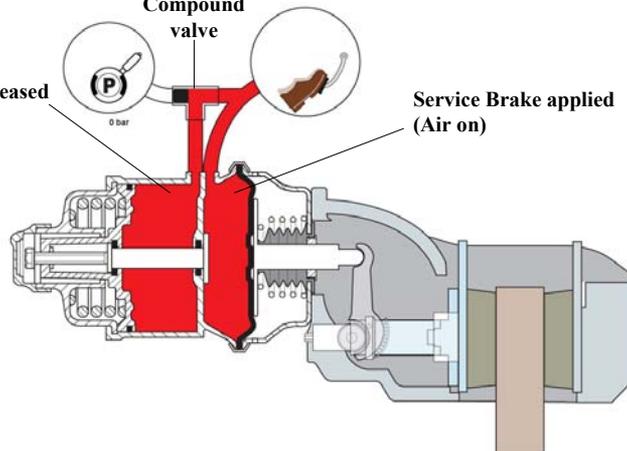
Anti
Compound
valve

Parking Brake released
(Air on)

Service Brake applied
(Air on)

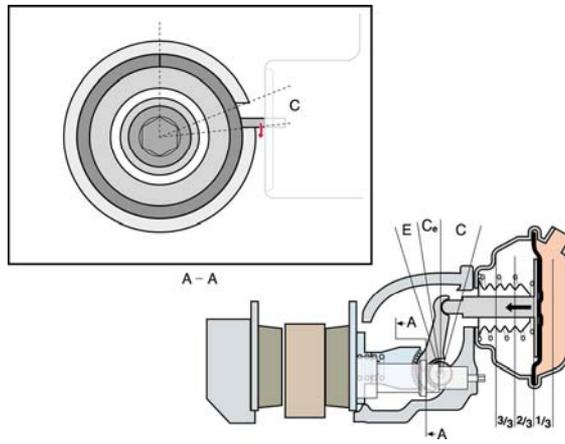
Function description

Application

C = clearance

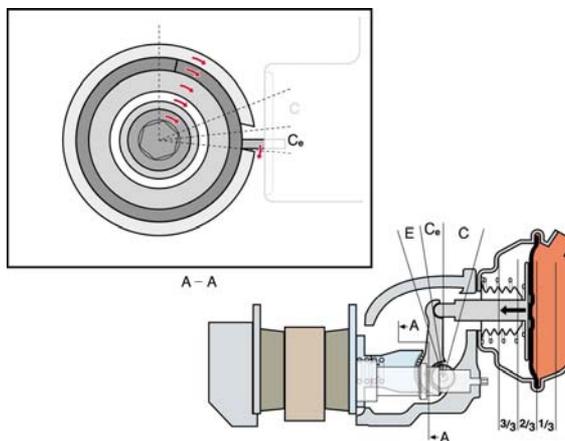
Function description

Application

Ce = excessive clearance

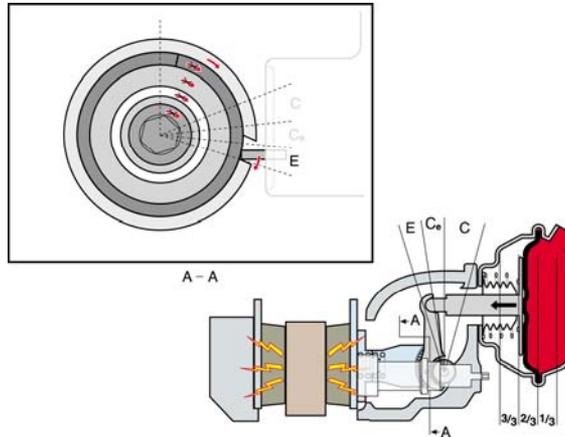
Function description Elasticity

Application

E = elasticity

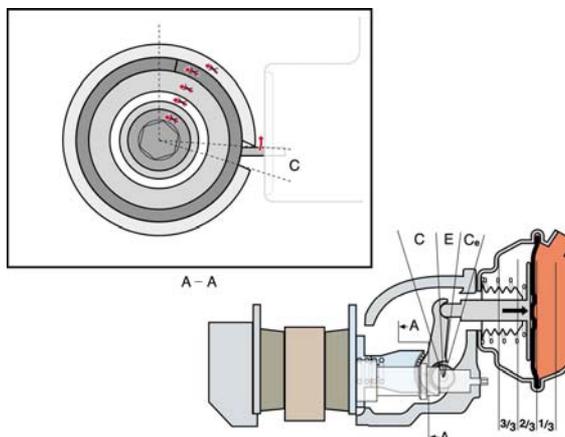
Function description Clearance

Release

C = clearance

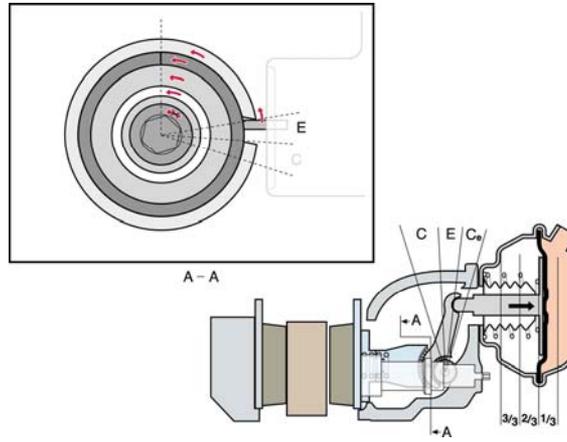
Function description Elasticity

Release

E = elasticity

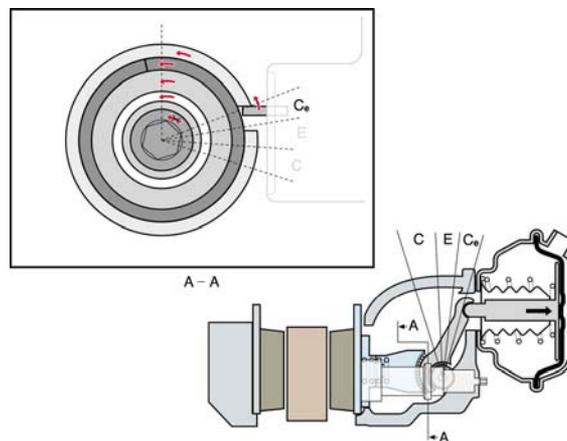
Function description Excessive Clearance

Release / back
in rest position

C_e = excessive
clearance

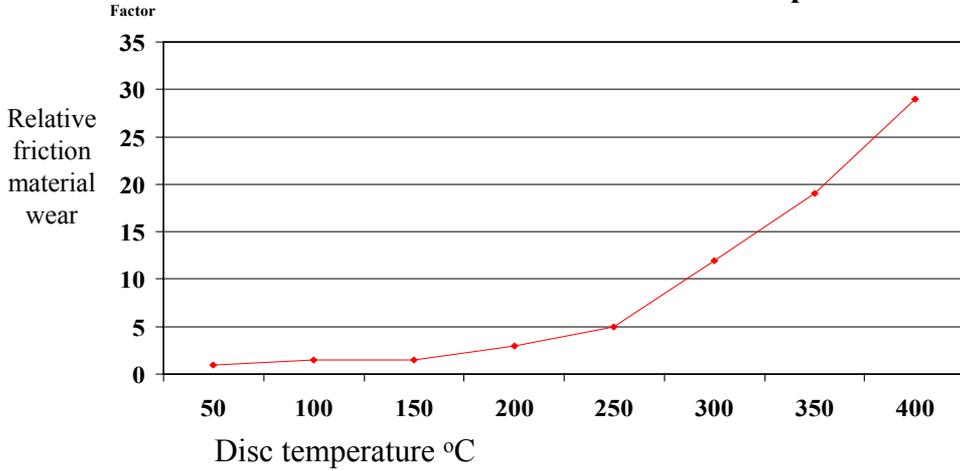
Thermal overload

Pad friction material wear in relation to temperature.

Summary, Thermal Overload:

- Just to change damaged components doesn't solve the problem - the new components will get damaged as well!
- Each axle/vehicle in a combination must perform braking in relation to the weight it is carrying for the moment - dynamics included.

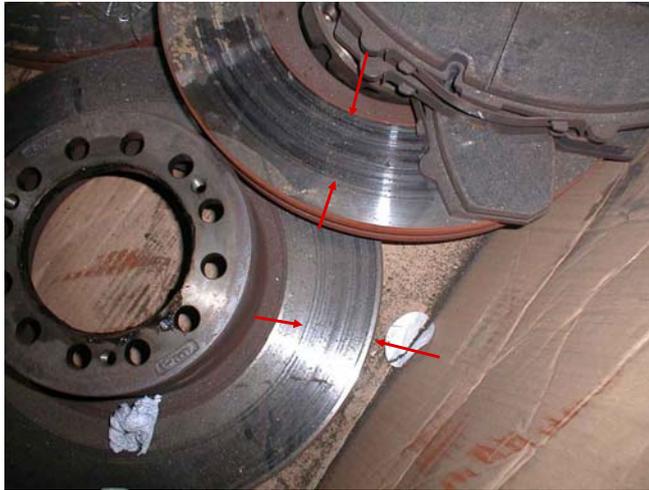
Thermal Overload

Heat distortion

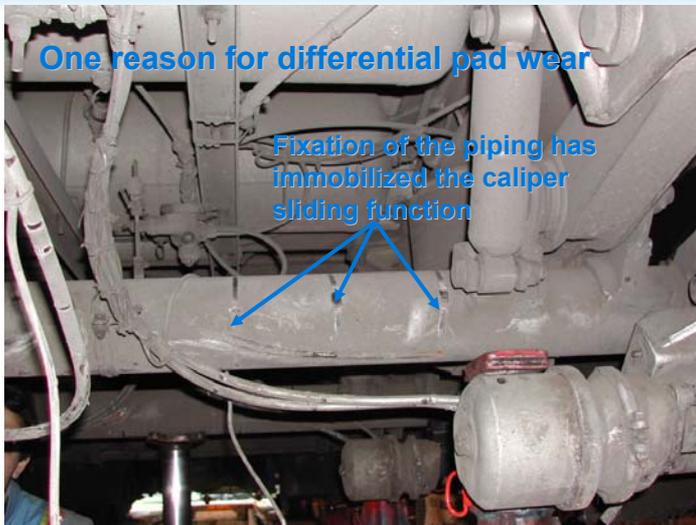
Accelerated wear of inner pad

One reason for differential pad wear

Fixation of the piping has immobilized the caliper sliding function

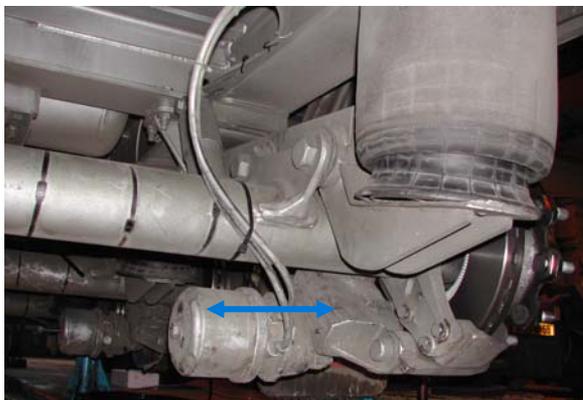
Equal wear on inner/outer pad

Wear compensation: The caliper must be allowed to have free floating, without influence of directing forces, throughout the complete caliper travel (needed for compensation of pad wear).

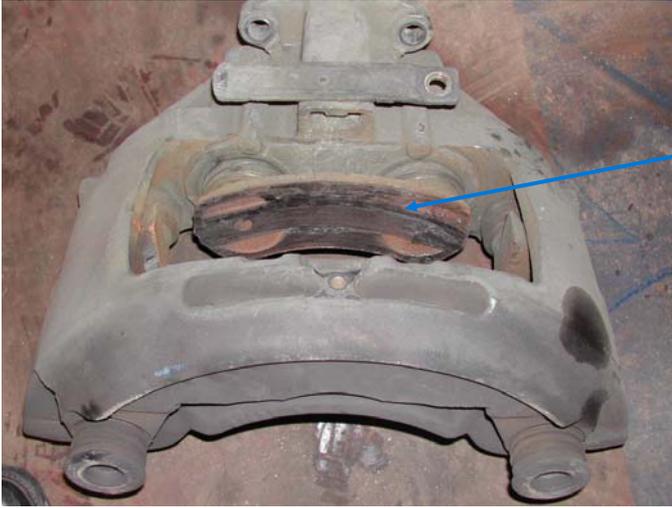
Damaged thrust plates

The thrust plate has been in contact with the disc = worn out pads, including the back plate! (Inspections?)

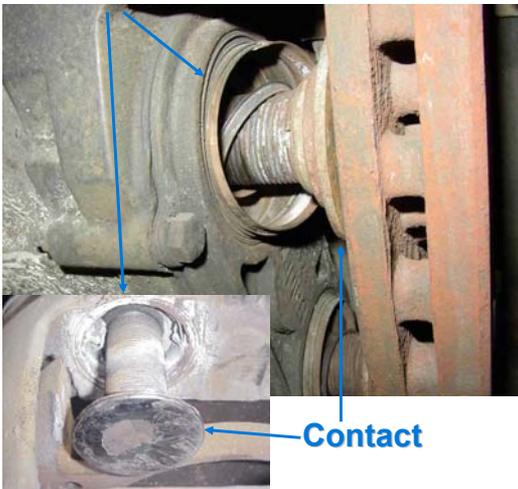
Contact damages

Bellows burnt

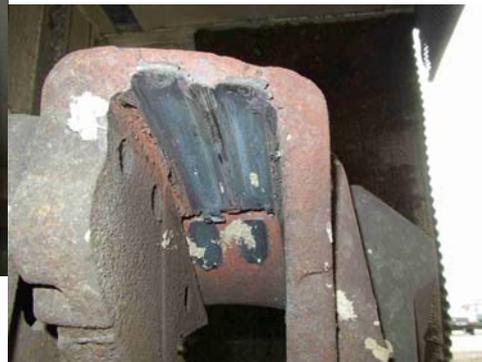
Wheel bearing break down

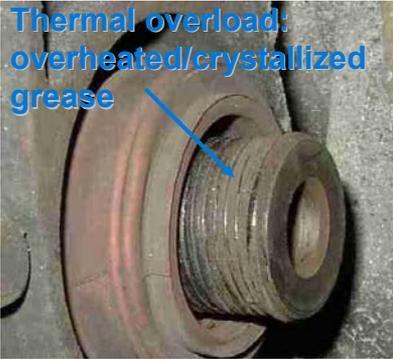
Impossible to release the brake adjustment enough to fit new pads?

Thermal overload:
overheated/crystallized
grease

Change bellows, clean /put
new high temp. grease on
the adjustment screws and
- - - rectify the root cause!

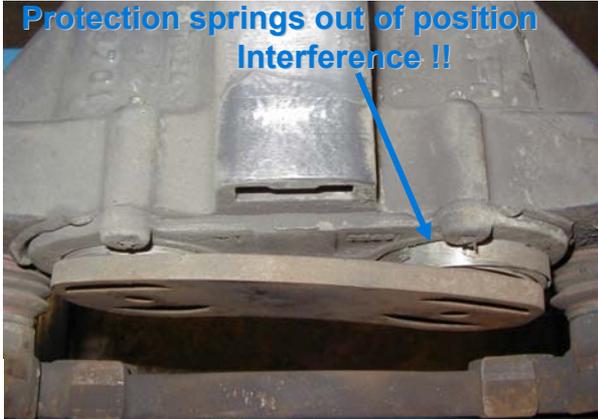
Protection springs out of position
Interference !!

Note! The protection spring must be put
back in its ordinary position!

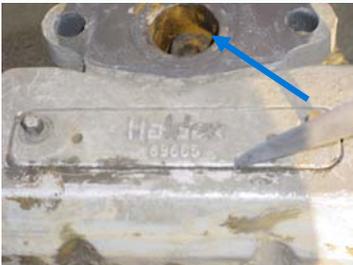
Water ingress → corrosion

Sealing joints

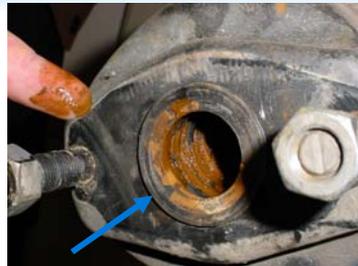
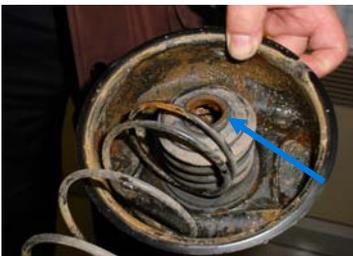
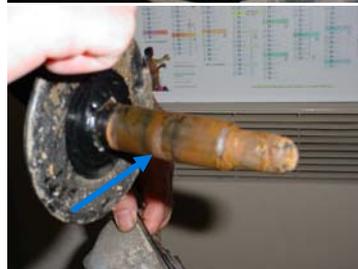
The brake chamber housing will be filled with water = at temperature below 0° C the water will freeze which will/may immobilize the brake chamber, damage the diaphragm etc.

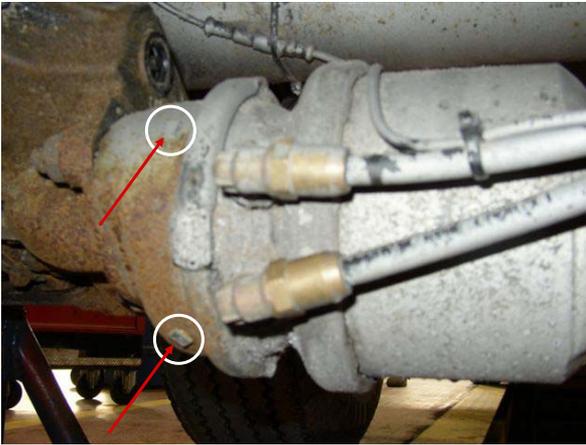
Water ingress → functional disorder

All plugs in the brake chamber housing fitted !

This means no ventilation = vacuum will immobilize the brake chamber = the disc brake will not work!

This will/may be identified as a non functional disc brake !

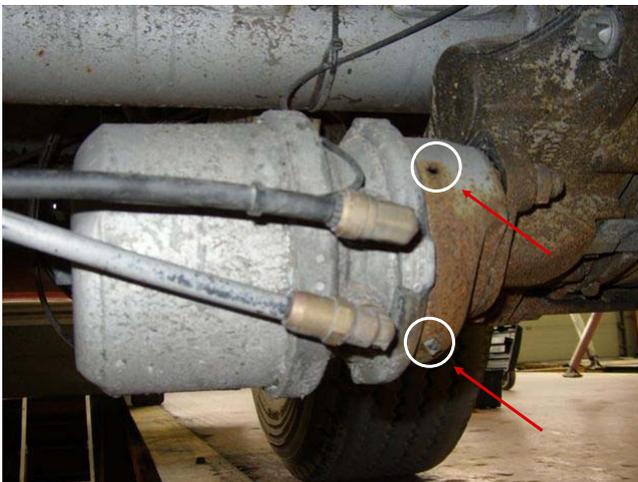
Water ingress → functional disorder

The upper plug is removed

The bottom plug is fitted

Immobilized brake chamber will/may be identified as a non functional disc brake!

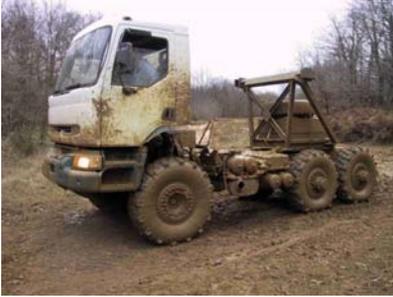
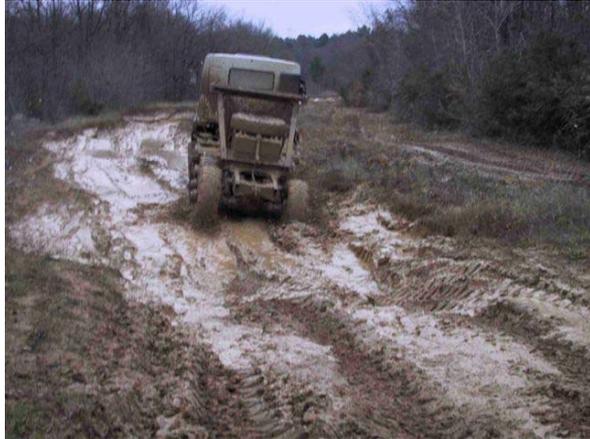
Water - dirt – accelerated wear

Pad wear: 20 - 30 Km = 7mm !

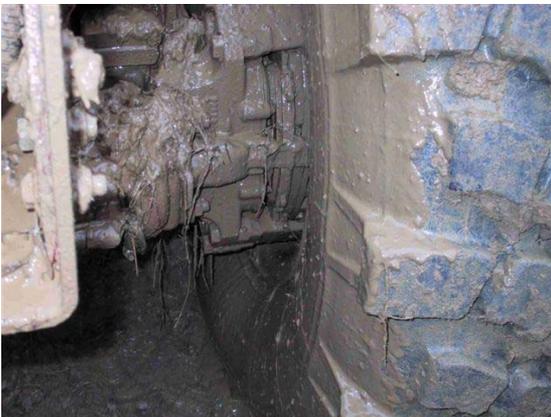
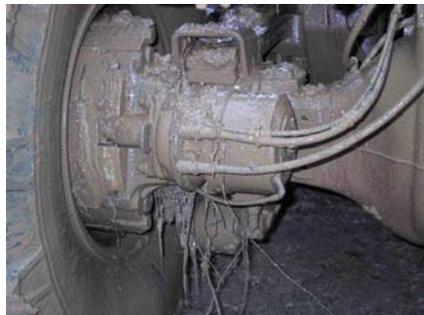
Water - dirt – accelerated wear

Without protection

With protection
